DESIGN GUIDELINES
FOR
MURPHY STATION
HERITAGE LANDMARK
DISTRICT
Adopted July 2019

City of Sunnyvale

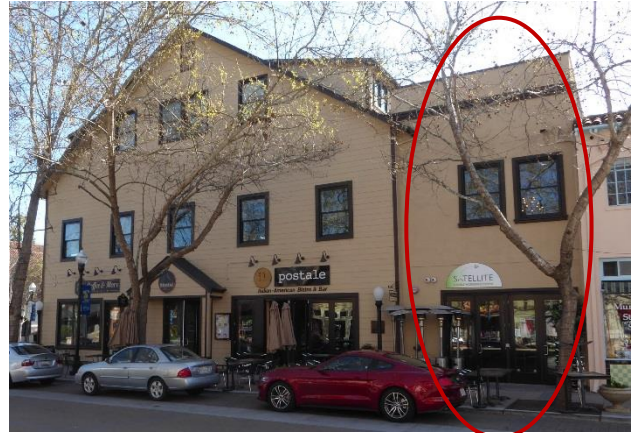
Overall building, Murphy Avenue elevation; circled area is later addition to the building.

- Extend horizontal wood siding onto two-story 1993 addition, but consider a slight variation in siding width to differentiate old from new.
- Obtain Sign Permit for existing signage (no permit history found for signage).
- Add gooseneck lights for all building signage.

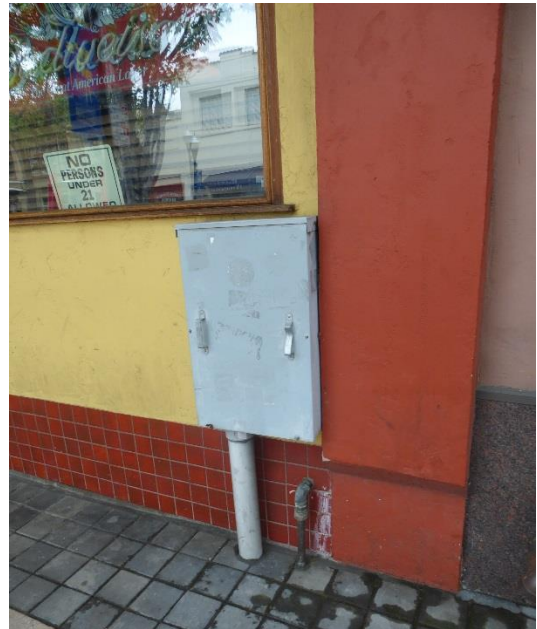
Above: Electrical box and conduit that distract from the buildings architectural features.

- Conduit and meters should be minimized at Murphy Avenue façade and priority given to relocating these (if possible).
- Consider enlarging (restoring) size, shape and configuration of storefront windows. Uncover door windows.
- Paint electrical panel on Murphy Avenue façade to match building.
- Remove ATM signs on the awning (not allowed).
- Replace entry doors with a door type that is more compatible with the building and the District.

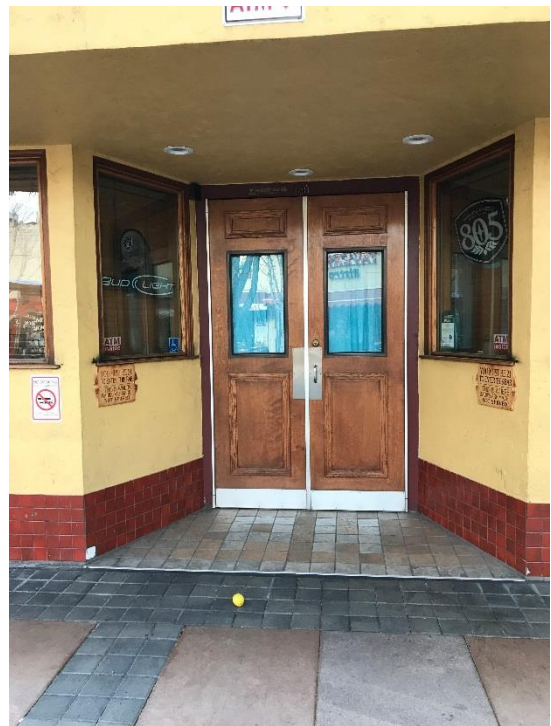
Above: Current entry doors are not historic and could be replaced with doors that are more in keeping with commercial buildings of this era

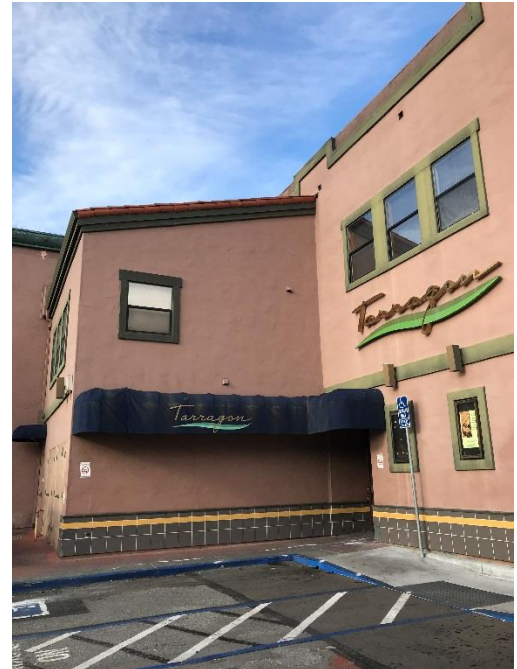
Above: The rear façade has an awkwardly placed awning that should be reconfigured or removed.

- Future modifications to the building should strive to contribute more to the character of the overall District
- Remove the current awning and replace with one that is more compatible with the building and the District (e.g. an awning that spans across the front façade).
- Remove/reconfigure rear awning.
- Consider a change in color scheme by lightening the main paint color and using a darker color for the accents and trim.
- Consider removal of the tile from the second level roof to make the building more compatible with adjacent structures, and contribute better to the District.
- Ensure consistent building trim colors on front and rear facades.
- Replace marble base with a tile base that is more compatible with the District.

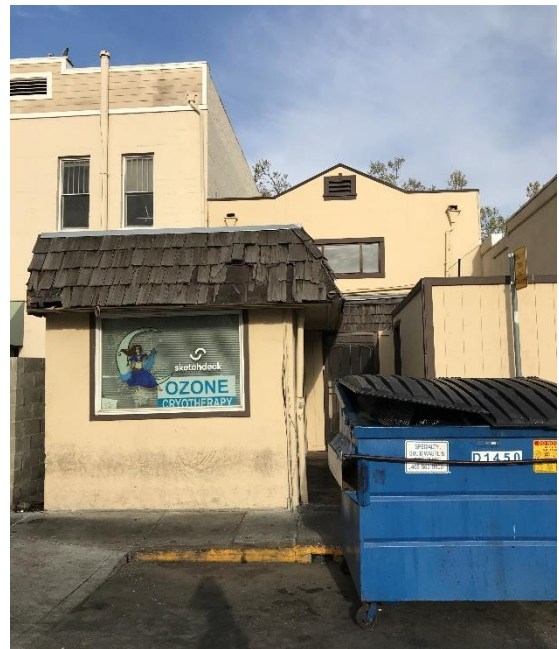
Above: Rear of storefront showing outbuildings and garbage dumpster.

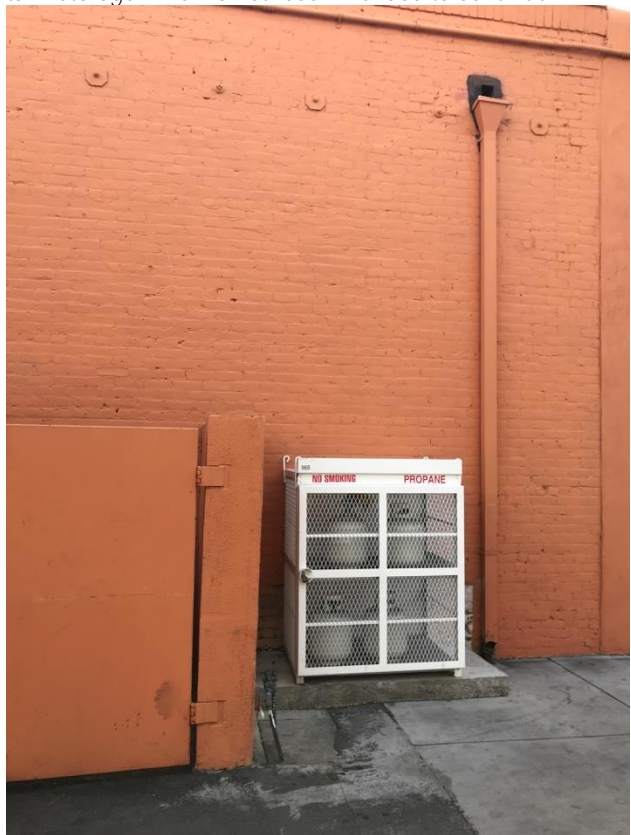
Below: The side elevation at the alley. Note the propane tank storage which is not recommended to continue.

- Maintain paint coatings at the upper story window surrounds and sills.
- Remove propane tank storage from alleyway off Washington Avenue.
- Replace windows on one-story Washington tenant space to a style that is more compatible with the District/building. The current windows are too contemporary.
- Remove gateway structure at rear of building.

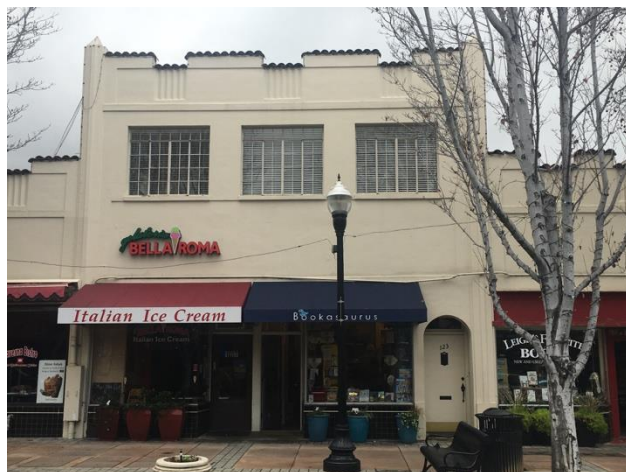
Above: The awnings on each storefront are different colors, sizes and materials. Uniformity of the awnings in shape, size and material could be considered.

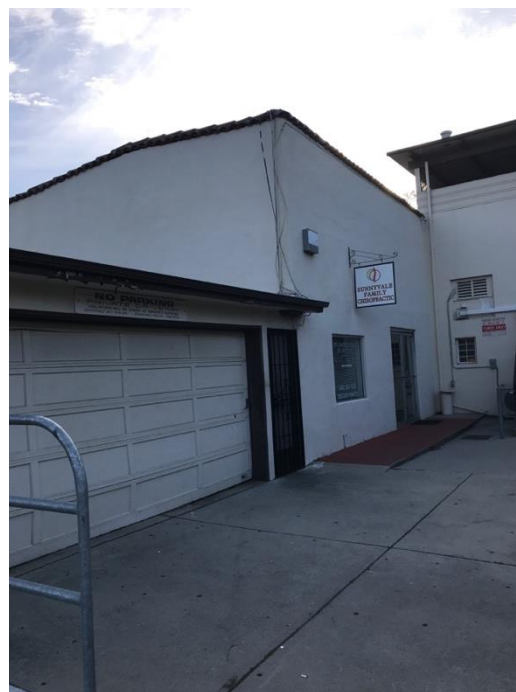
Above: The rear wing and garage are in need of repair, paint and on-going maintenance.

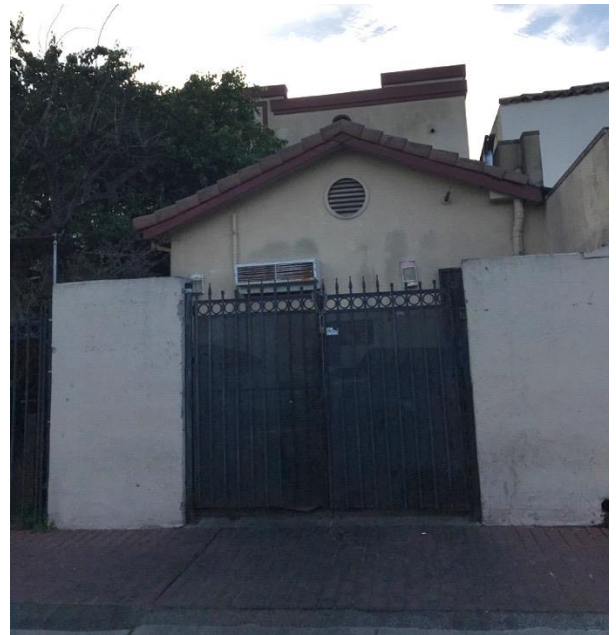
Above: A view of the rear elevation showing the metal gate and lack of design details or interest to engage the pedestrian at this side of the building.

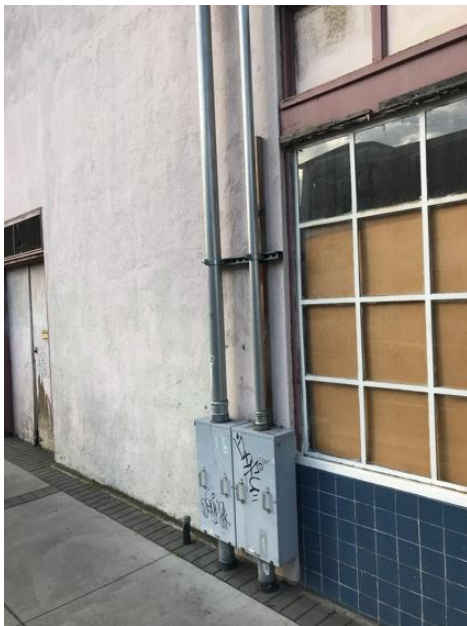
Above: Detail of utility boxes mounted at elevation.

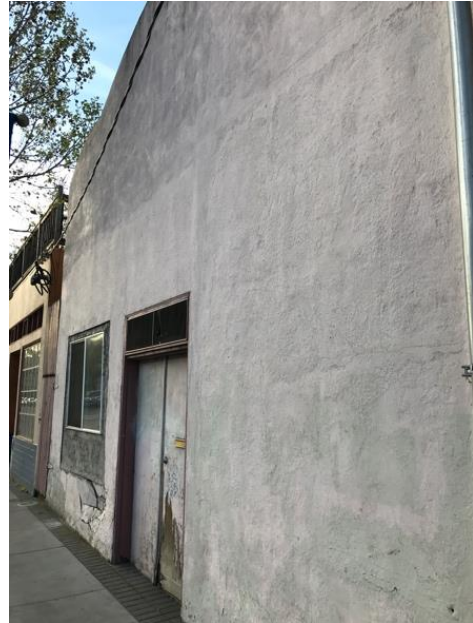
Above: View of required repairs to stucco, windows and doors at the Evelyn Avenue façade.
