DESIGN GUIDELINES
FOR
MURPHY STATION
HERITAGE LANDMARK
DISTRICT
Adopted July 2019

City of Sunnyvale

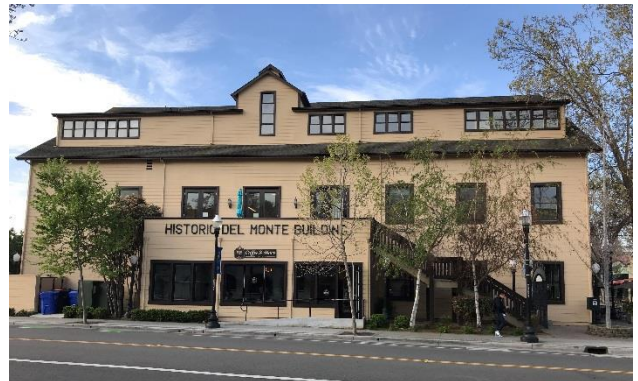
Overall building, Murphy Avenue elevation; circled area is later addition to the building.

- Extend horizontal wood siding onto two-story 1993 addition, but consider a slight variation in siding width to differentiate old from new.
- Obtain Sign Permit for existing signage (no permit history found for signage).
- Add gooseneck lights for all building signage.

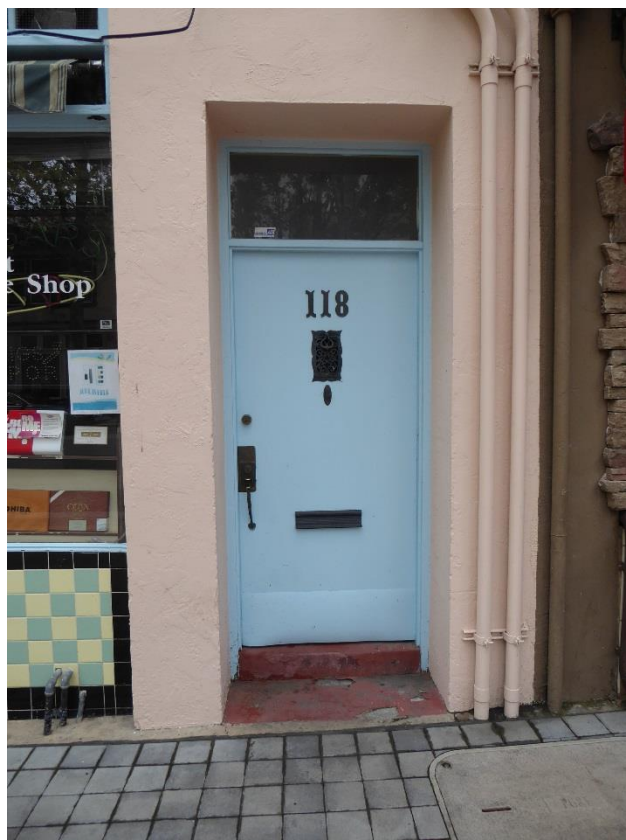
Above: Entry to upper story. Note exposed conduit.

- Conduit and meters should be minimized on the Murphy Avenue façade and priority given to relocating these (if possible).
- Remove unpermitted signage (State Farm) on the rear façade/gate of the building.
- Replace awning on front facade.

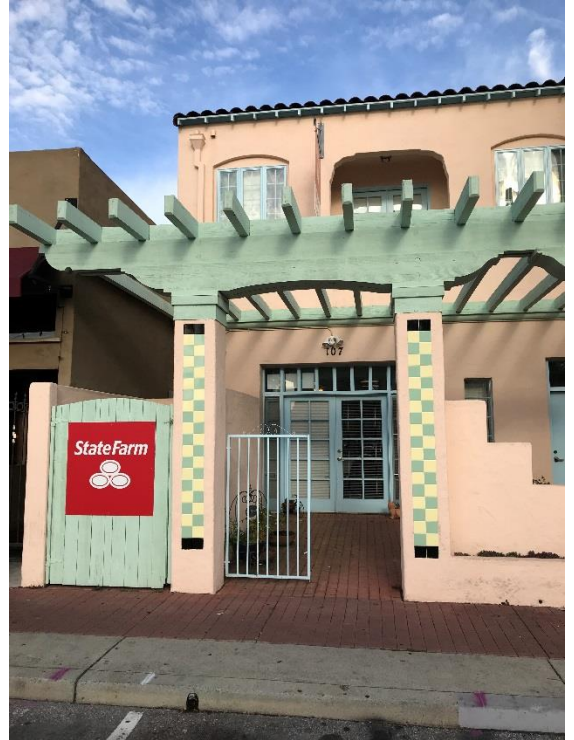
Below: Unpermitted State Farm sign on rear elevation

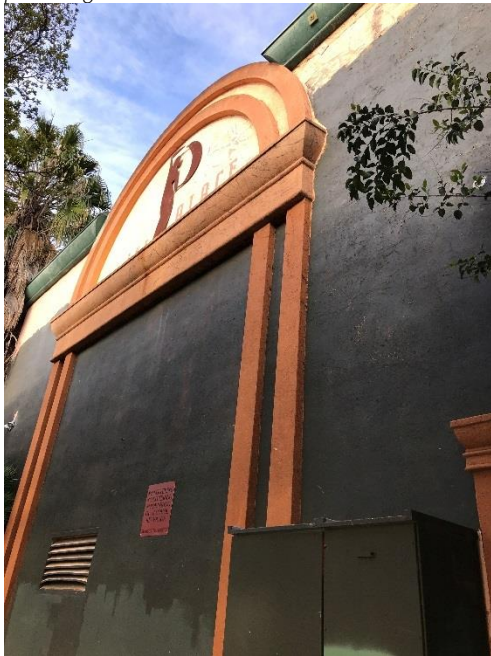
Below: Rear façade showing various paint schemes and patching.

- Expand tile base and replace with a tile color/style that is more compatible with the building/District.
- Repaint the entire building base the same color (all sides appear to be different colors) with priority given to the rear of the building where the paint line stops about three feet from roofline and is not a consistent color. Use color for trim or accent in limited locations.

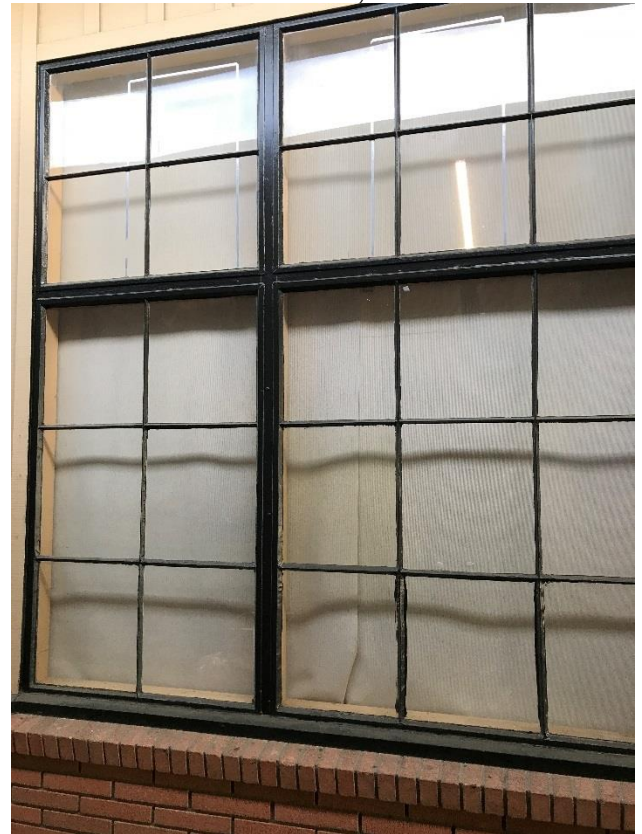
Above: Overdoor AC unit in breezeway.

Below: Covered windows in breezeway.

- Strive to make the building more compatible with the character of the District with future modifications.
- Redesign façade and storefront doors to be consistent with the District (e.g. recessed entryway).
- Remove stucco parapet as it is not compatible with the building due to its height, material and use of triangular element. Replace with a parapet design that is more compatible with the District.
- Replace current awning with an awning that is more angular; curved awnings are not compatible with this type of storefront.
- Remove tile accents from wall.
- Remove and relocate air conditioning units from doorways along breezeway.
- Enhance and activate the breezeway through future modifications.

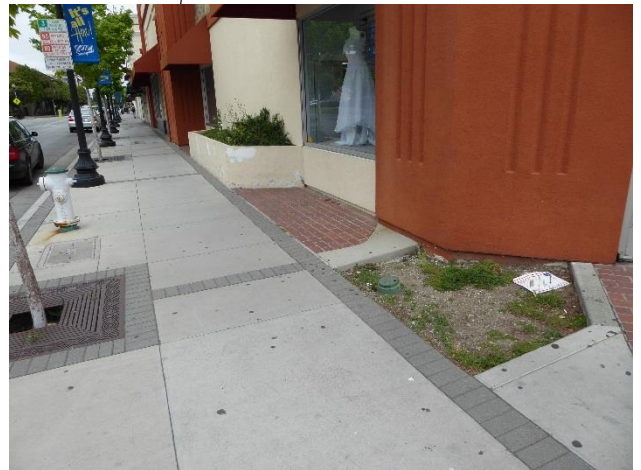
Below: Detail of planters.

- Landscape planters should be maintained or removed.
- Maintain planted area along S. Sunnyvale.
- Low wall along Washington Avenue is in need of repair.
- Update rear gate/fence with a style that is more compatible with the building and the District.
- Keep stored items within fenced area at rear of building.
- Exposed conduit and pipes should be minimized and priority given to relocating these (if possible).

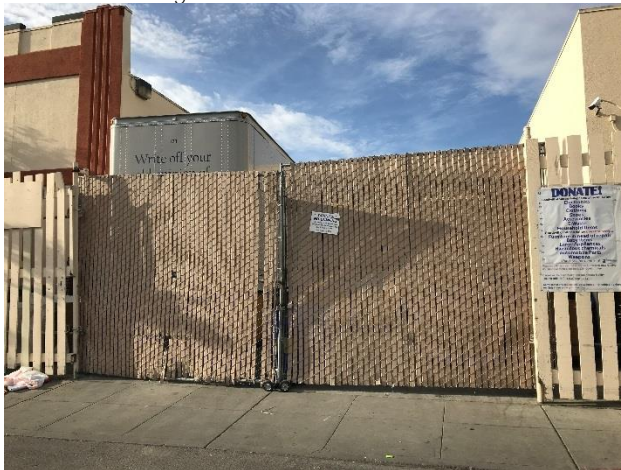
Below: Detail of gates.

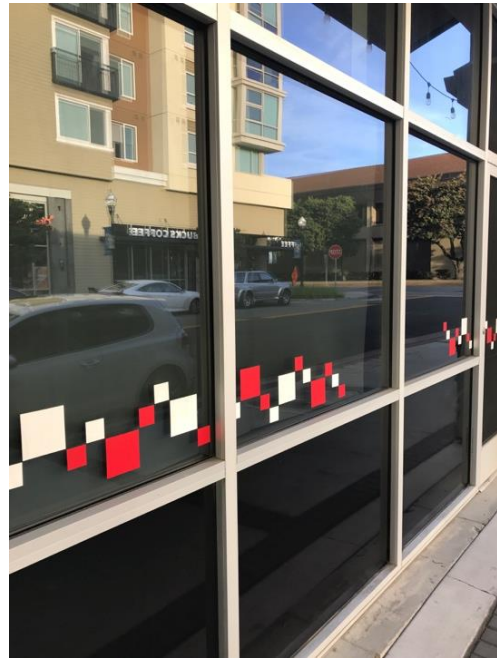
Above: A detail of the tinted windows on Frances Street.

- Conduit and meters should be minimized at Murphy Avenue façade and priority given to relocating these (if possible).
- Replace tinted windows at storefront with clear glass.

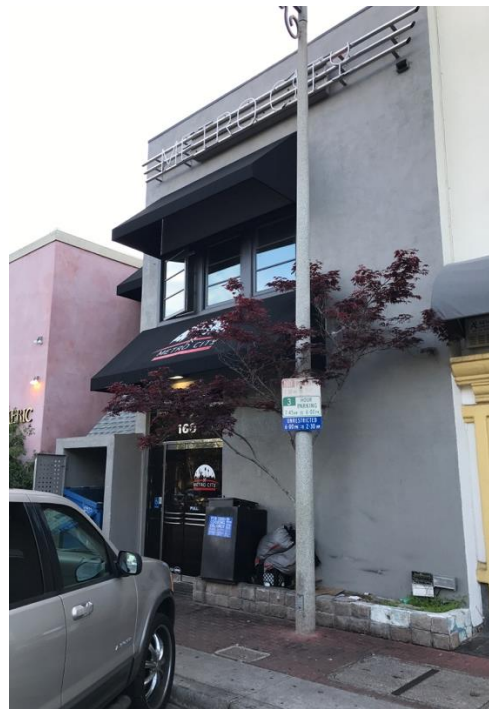
Above: Rear façade showing two stories.

- Conduit and meters should be minimized at Murphy Avenue façade and priority given to relocating these (if possible).
- Consider variation in the form of the parapet, similar to other buildings in the District.
- Replace trash enclosure door (missing one door) in rear of building.
- No materials should be stored at outside area in rear of building. Storage of items related to restaurant use should be located inside the tenant space or within an existing screened storage area.

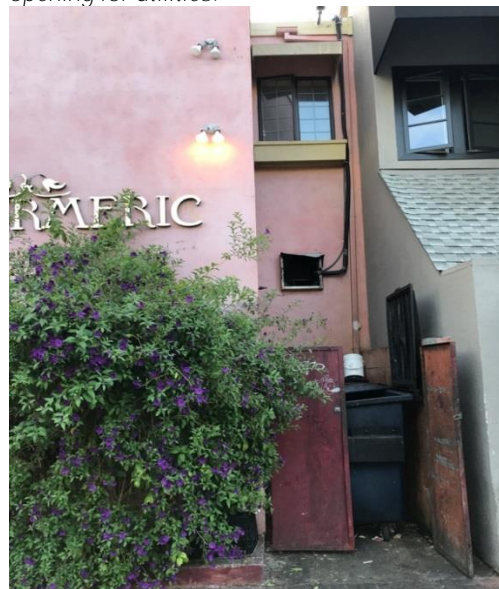
Below: Detail of rear showing trash enclosure and opening for utilities.

- Future modifications to the building should strive to make the building more compatible with the character of the District.
- Conduit and meters should be minimized at the Murphy Avenue façade and priority given to relocating these (if possible).
- Replace front awning with one that spans across the building.
- Re-paint building with a lighter color base with darker color(s) for trim and accent.
- Open up the front façade with additional windows or openings.
- Replace second story windows with a window design that is more compatible with the District
- Replace rear awnings.
- Cover the large utility opening at rear façade.
- Re-paint rear trash enclosure to remove graffiti and replace the roof of the structure.
- Power wash pavement at rear of building (adjacent to trash enclosure) regularly to ensure the area remains clean.

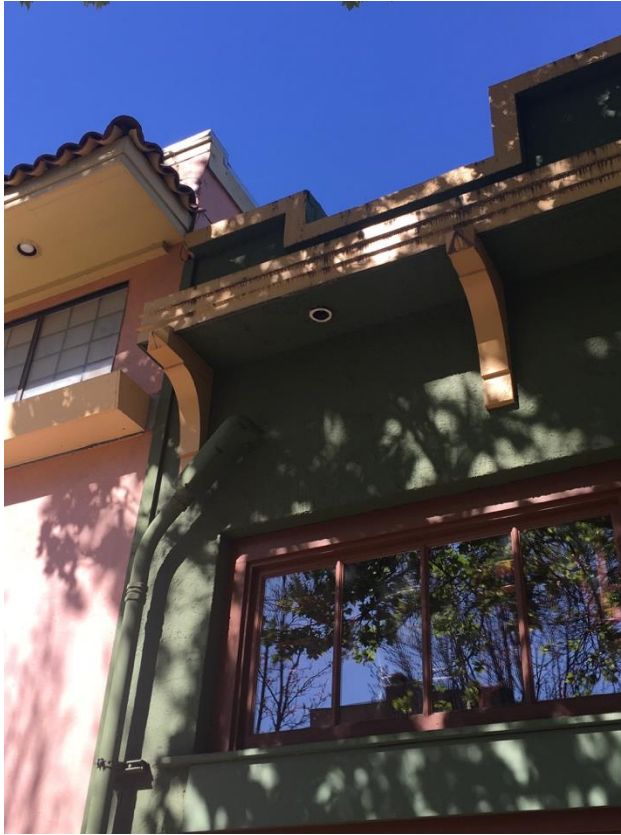
Above: Front transom detail and conduit on façade.

- Conduit and meters should be minimized at Murphy Avenue façade and priority given to relocating these, if possible.
- Retain tile base, but replace existing tiles with a tile/style that is more appropriate to the building design and District.
- Rear elevation is in good condition; however, future modifications should strive to make it more compatible with the District by employing fewer materials and providing consistent door openings.

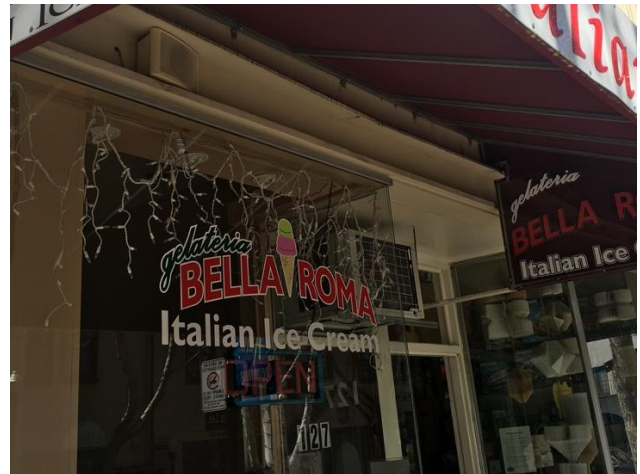
Below: This storefront has a window air conditioning unit in the transom above the door.

- Retain recessed store entries in historic configuration.
- Retain storefront doors and over door transom windows. Eliminate air conditioning units above storefront doors and find other solutions to cooling interior spaces.

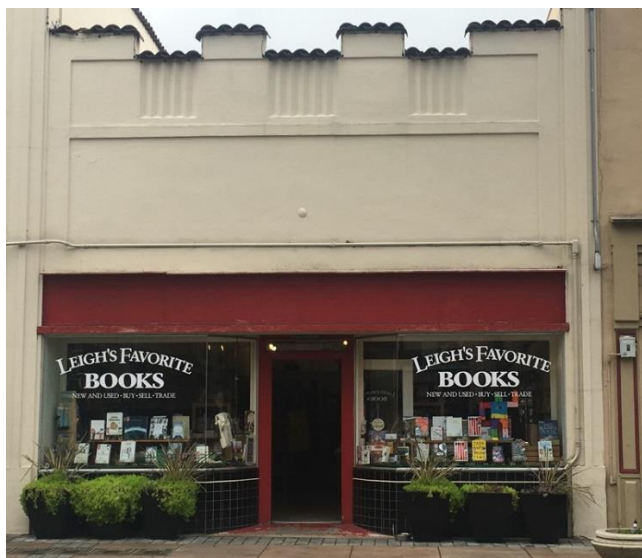
Below: These planters distract from the historic tile at the base of the storefront.

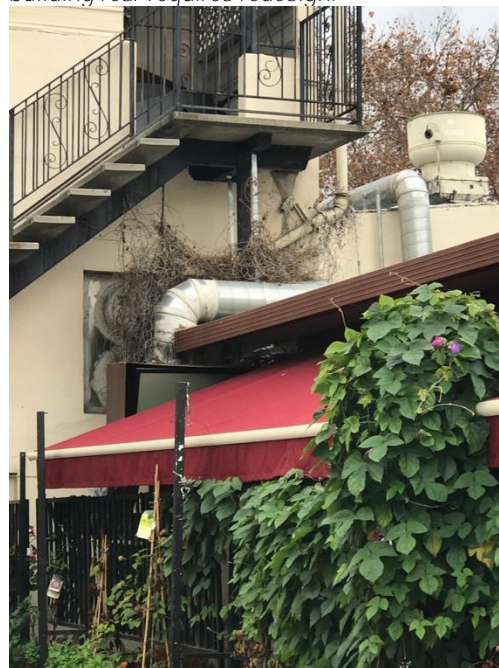
Below: The large, unsightly air ducts and venting at the building rear requires redesign.

- Replace the air duct at rear with a smaller duct and paint the new duct to match the existing building color, or relocate to an area that is out of the public view.
